Monitoring Cruise at the Morris Cove Borrow Pit

Disposal Area Monitoring System DAMOS

Contribution 129
June 2001

**US Army Corps
of Engineers®**
New England District

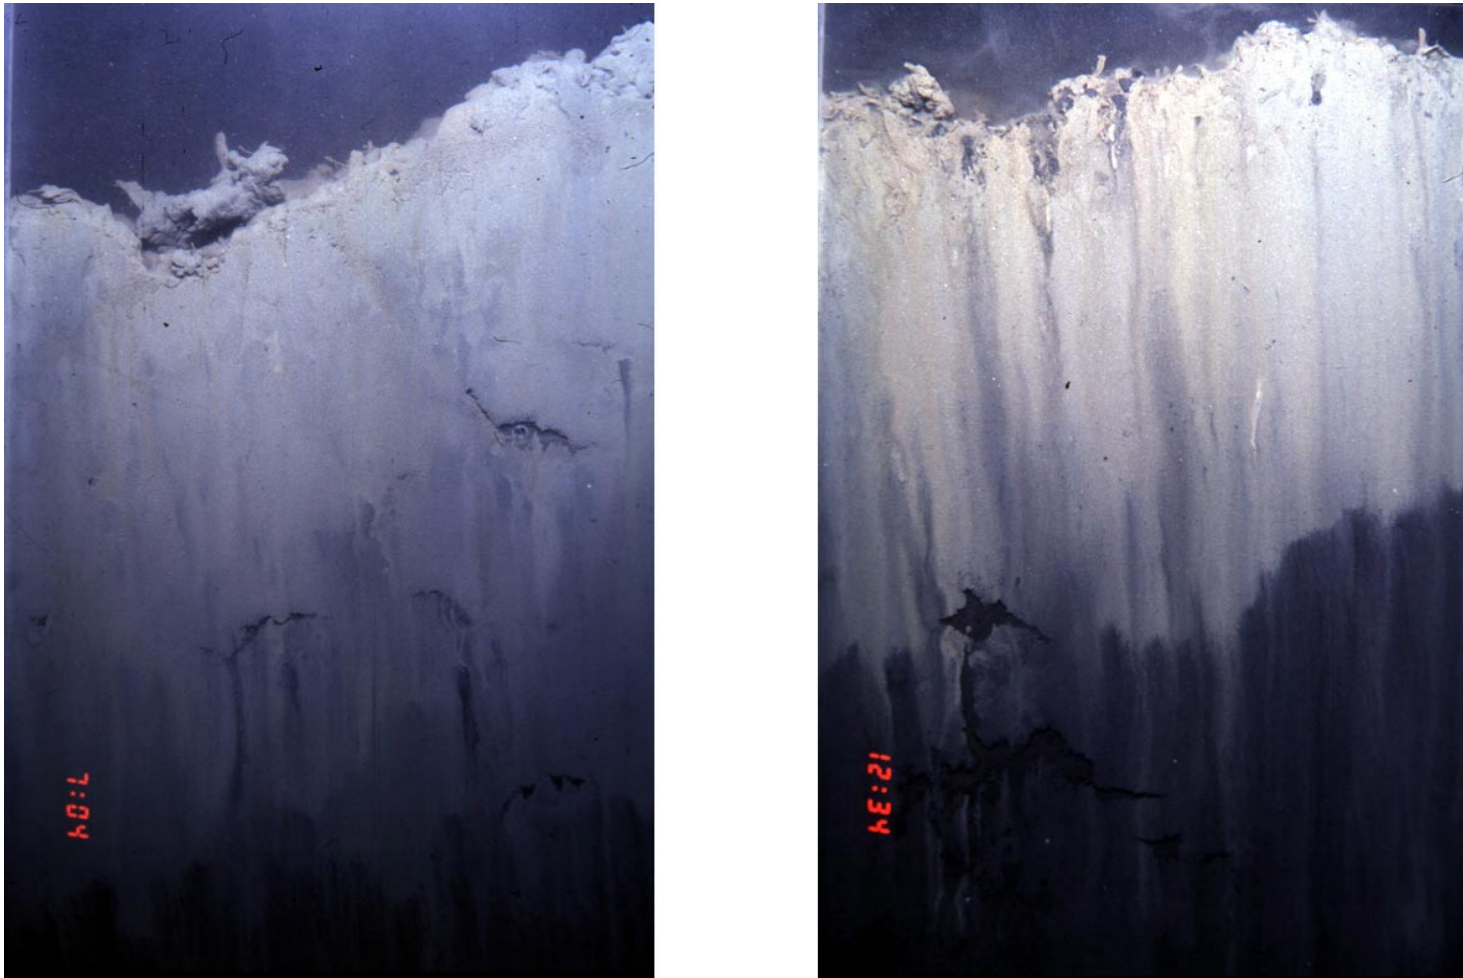
Figure 3-9. REMOTS® images from station 50E (left) and 150S (right) showing Stage I and II tubes visible at the sediment surface, and feeding voids (evidence of Stage III activity) at depth within the sediment.

polychaetes present at the sediment surface (Figures 3-7 and 3-8; Table 3-1). Tube-dwelling amphipods (*Ampelisca* sp), representative of Stage II, were observed at 7 of the 22 stations (Figures 3-7 and 3-9). Stage III activity, evidenced by active feeding voids produced by head-down, deposit-feeding infauna, was predominately noted in the subsurface at Stations 100NE, 100SW, 150NW, 150S, and 50E (Figures 3-7 and 3-9). Overall, the presence of a diverse mixture of Stages I, II and III organisms at the stations within the borrow pit indicate that benthic recolonization of this area was occurring as expected at the time of the September 2000 survey.
